MATHAY DAM
MERCER COUNTY, COMMONWEALTH OF PENNSYLVANIA
NDI No. PA 00247
PennDER No. 43-46
SCS No. PA 459

PHASE I INSPECTION REPORT
NATIONAL DAM INSPECTION PROGRAM

Mathay Dam, Mercer County, Pennsylvania
NDI No. PA 00247, PennDER No. 43-46, SCS No. PA 459
Mathay Run
Inspected 26 April 1979

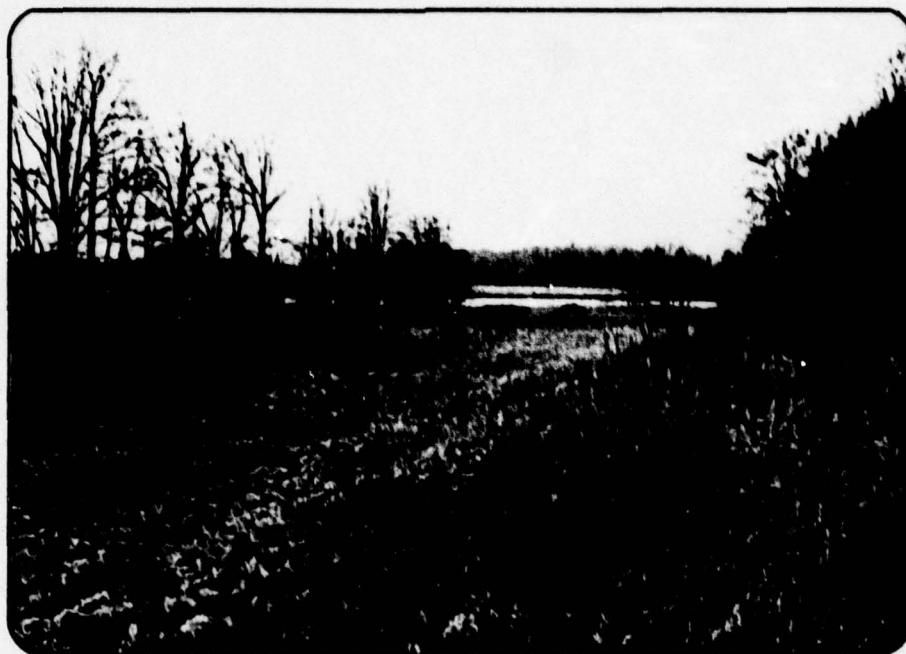
**PHOTO 3. View Looking Toward Pond in Upstream
Portion of Emergency Spillway Channel**
